CALSPAN ON-SITE NONDEPLOYED AIR BAG INVESTIGATION

CALSPAN CASE NO. 92-1

VEHICLE - 1990 TOYOTA CELICA

Calspan On-Site Non-Deployed Air Bag Investigation
Calspan Case No. 92-1
Vehicle - 1990 Toyota Celica GT
Location - [REDACTED] NY

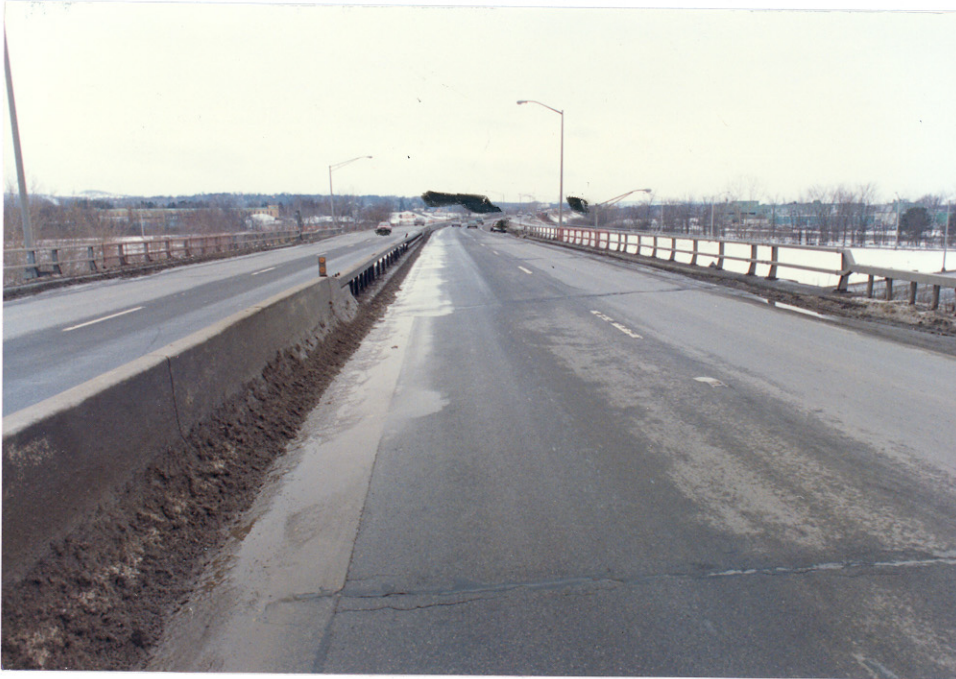
Pre-Crash trajectory of the 1990 Toyota Celica GT

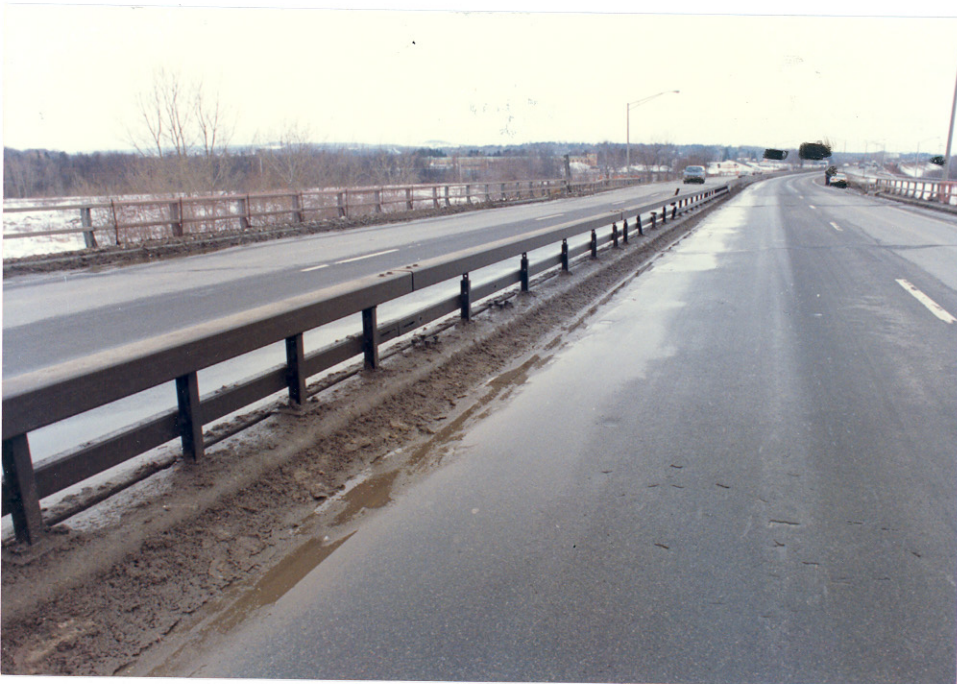
Struck box beam median barrier

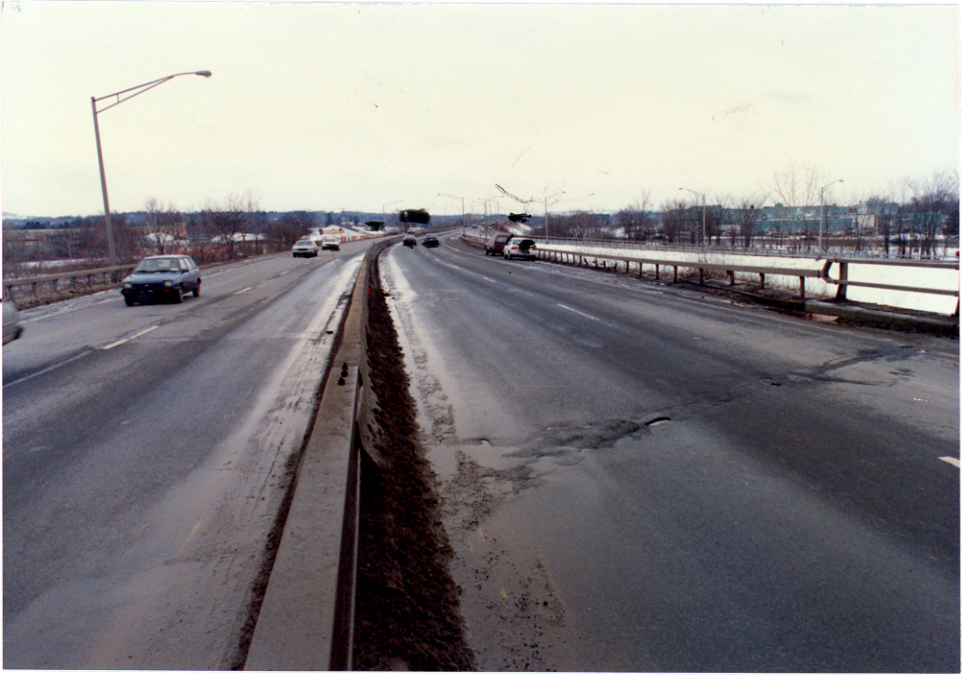
Vehicle rotates in a clockwise direction across travel lanes

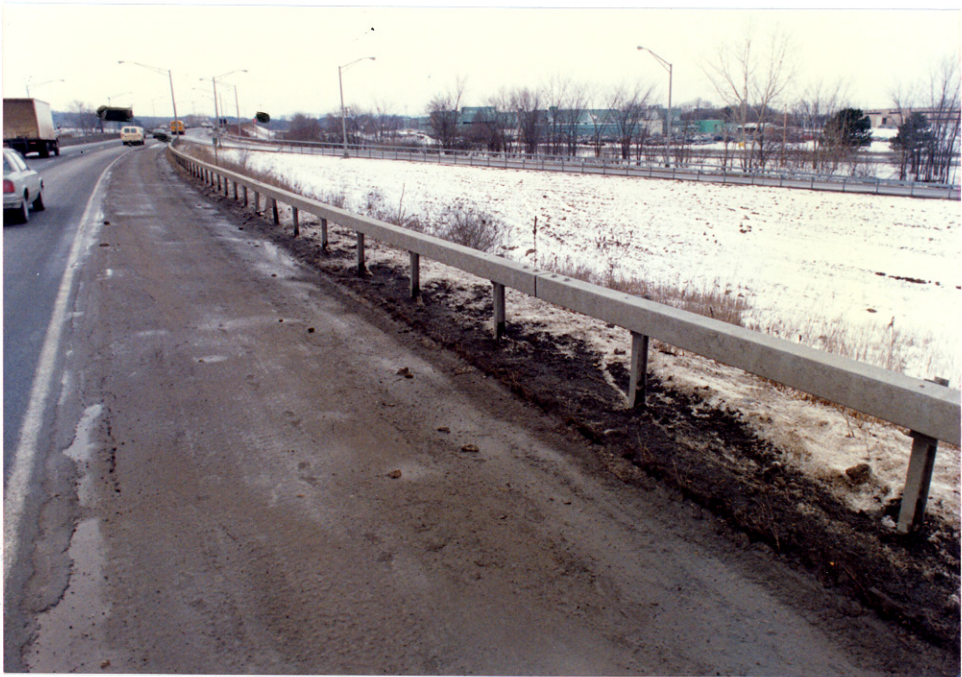
Frontal impact sequence with box beam guardrail

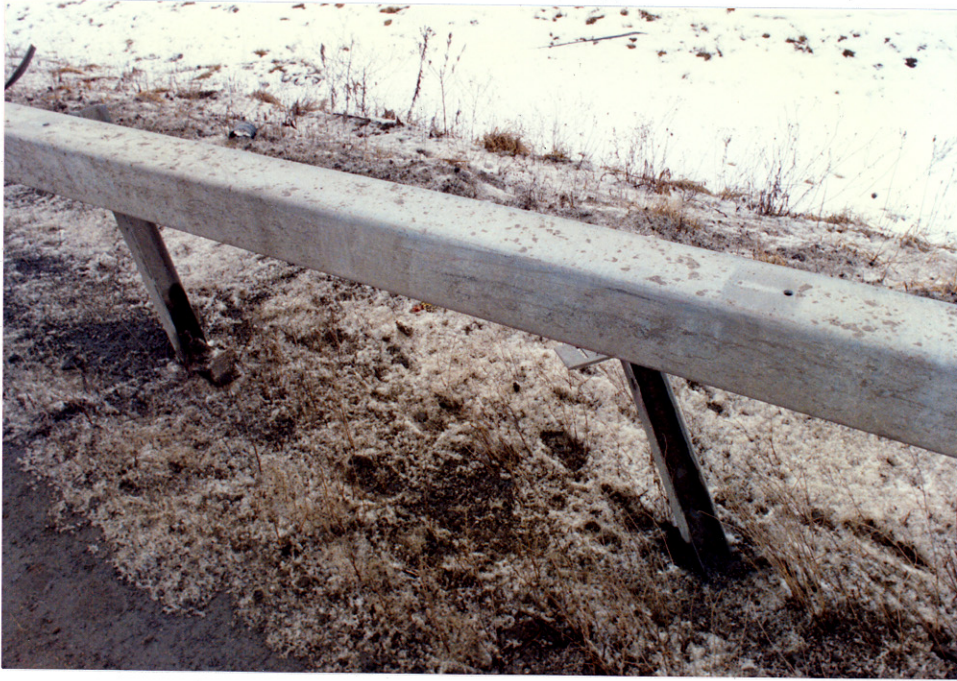
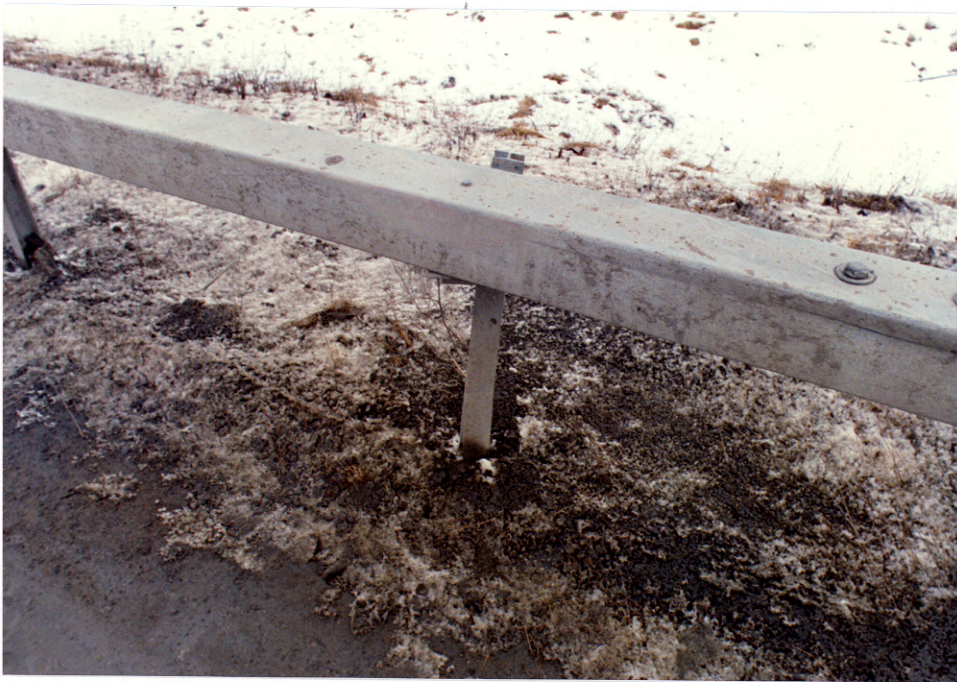
Possible areas of guardrail contact (Red paint transfers)

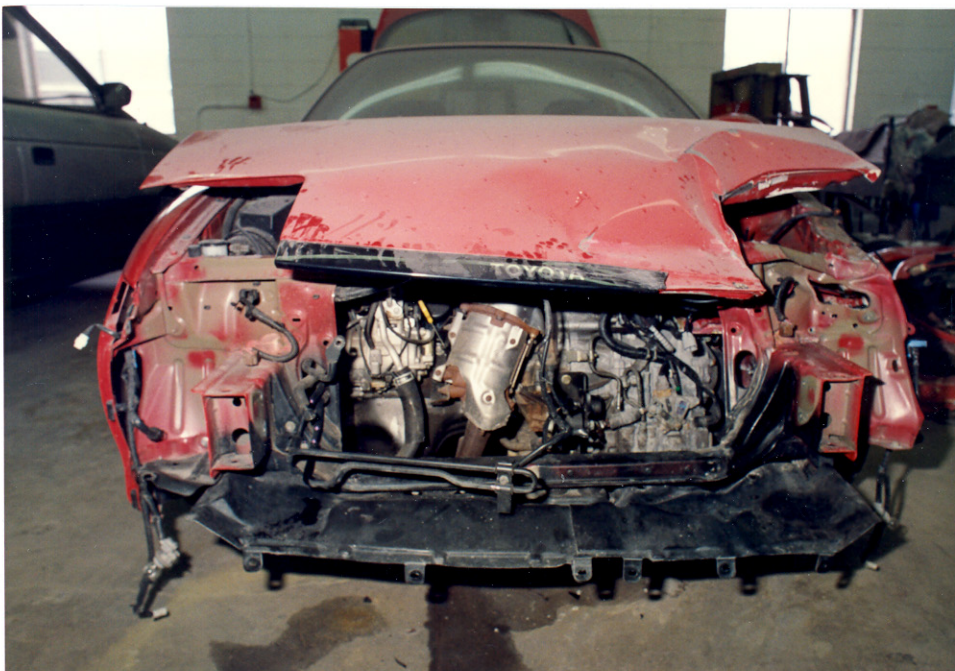
As the vehicle remained engaged with the box beam, its rotation was reversed from CCW (pre-impact) to CW. Due to the height of the guardrail (26" from paved shoulder to lower edge of box beam) and the CW rotation of the vehicle, the left front fender of the vehicle contacted and underrode the box beam guardrail. The top surface of the fender was crushed downward to a maximum depth of 2.5". Laterally oriented abrasions (direct contact damage) were located on the top surface of the fender which began at the leading edge and extended 22.25" rearward. The overall length of the fender was reduced from 50.5" pre-crash to 49.75" resulting in 0.75" of rearward displacement. The fender contact resulted in lateral displacement of the inner fender support structure forward of the shock tower. The lateral displacement of the fender support bucked the upper radiator support panel approximately 3" rearward.

Left frontal damage to the Toyota Celica GT

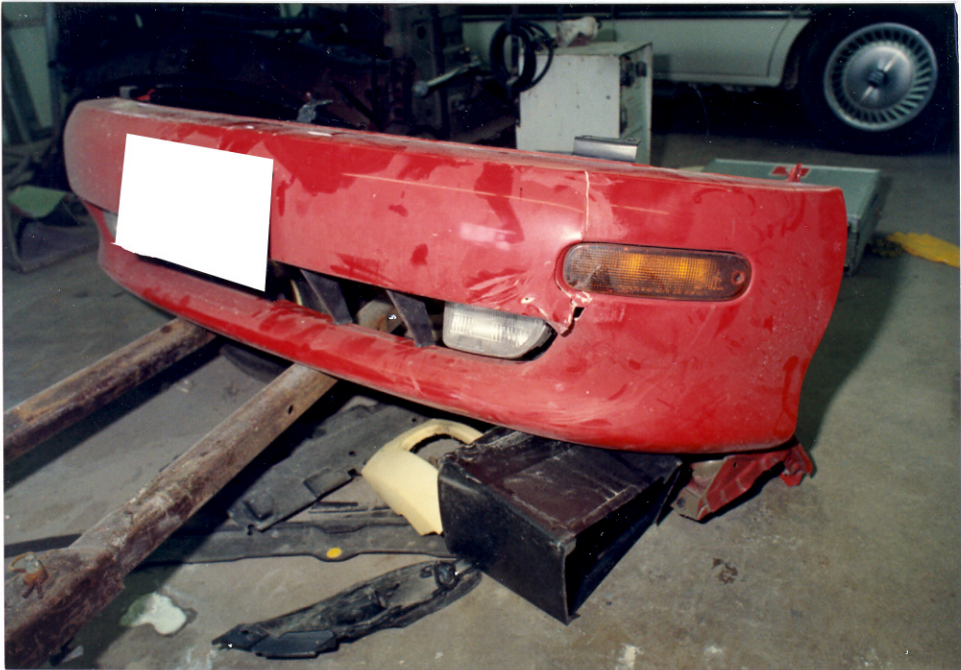
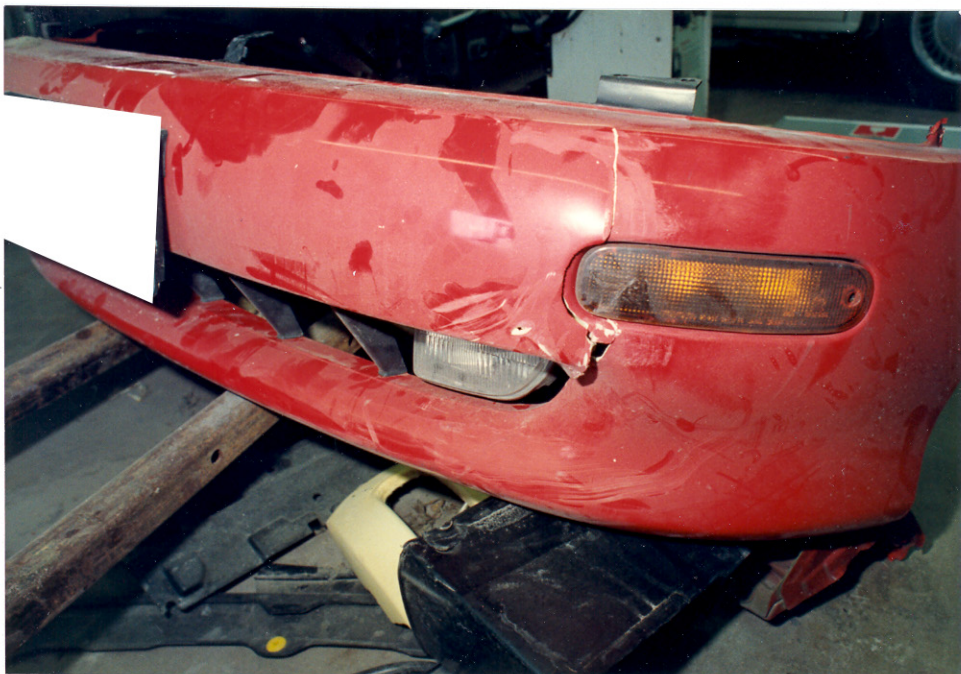
Direct contact damage to the front bumper fascia
(laterally orientated abrasions)

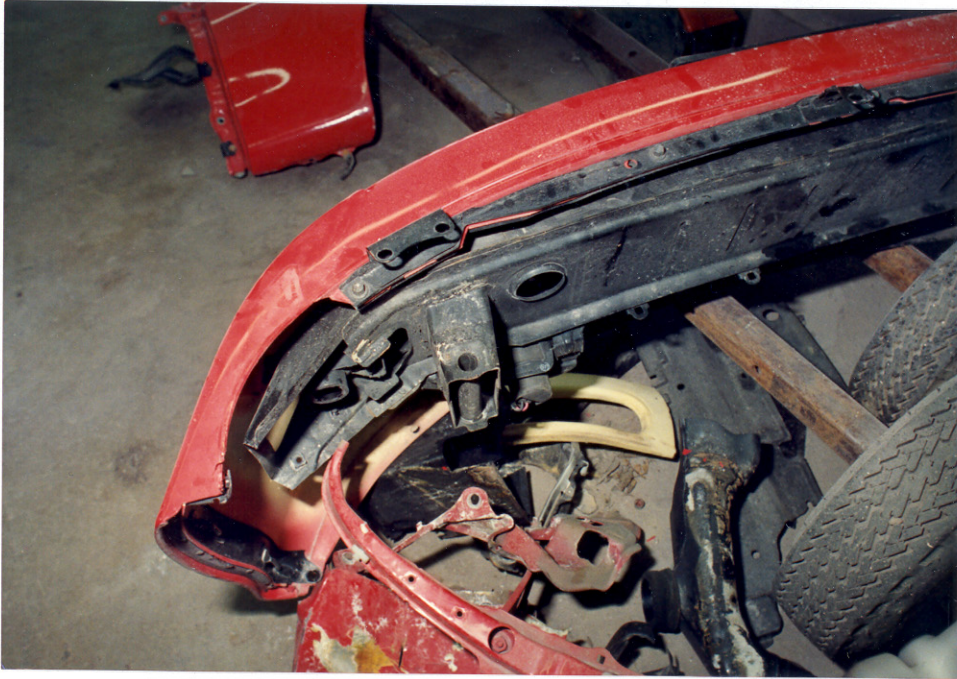
Left side view of the front bumper reinforcement bar

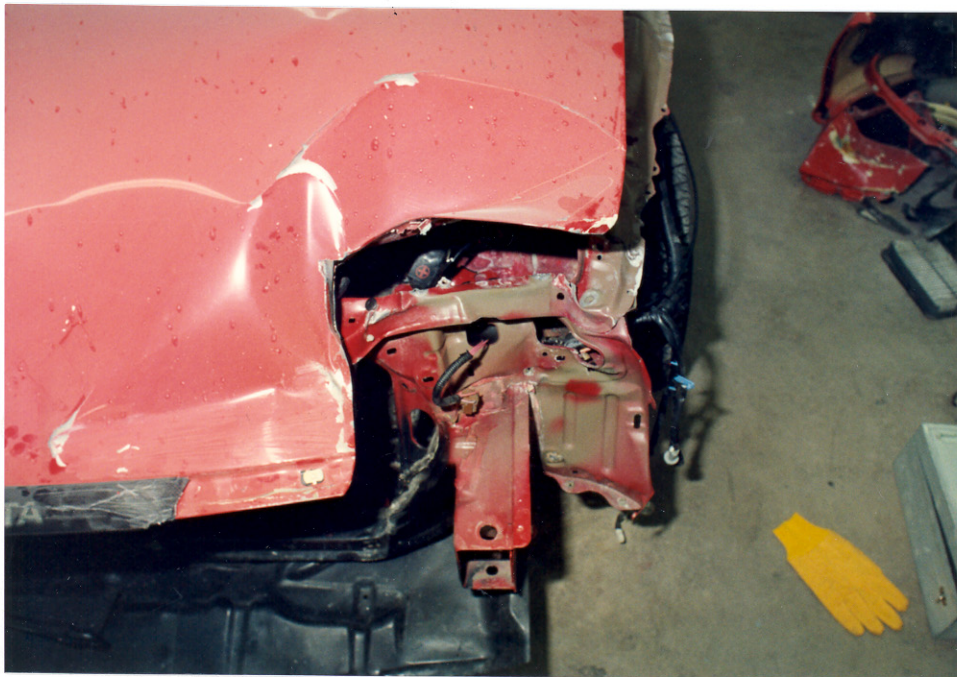
Sheetmetal deformation at the left frontal area

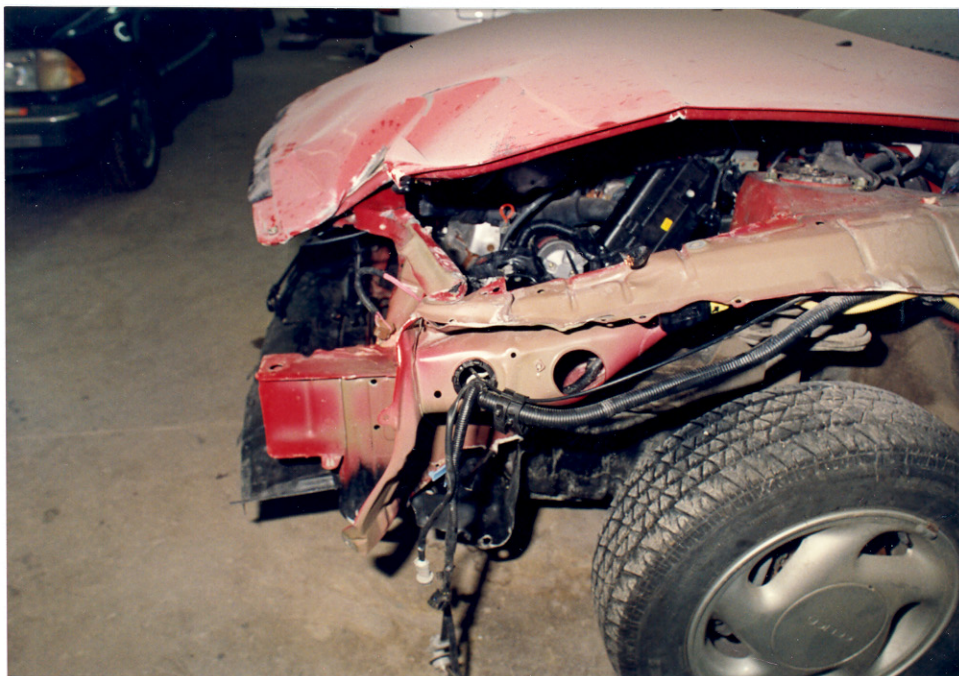
Perpendicular view of the displacement to the upper radiator support panel

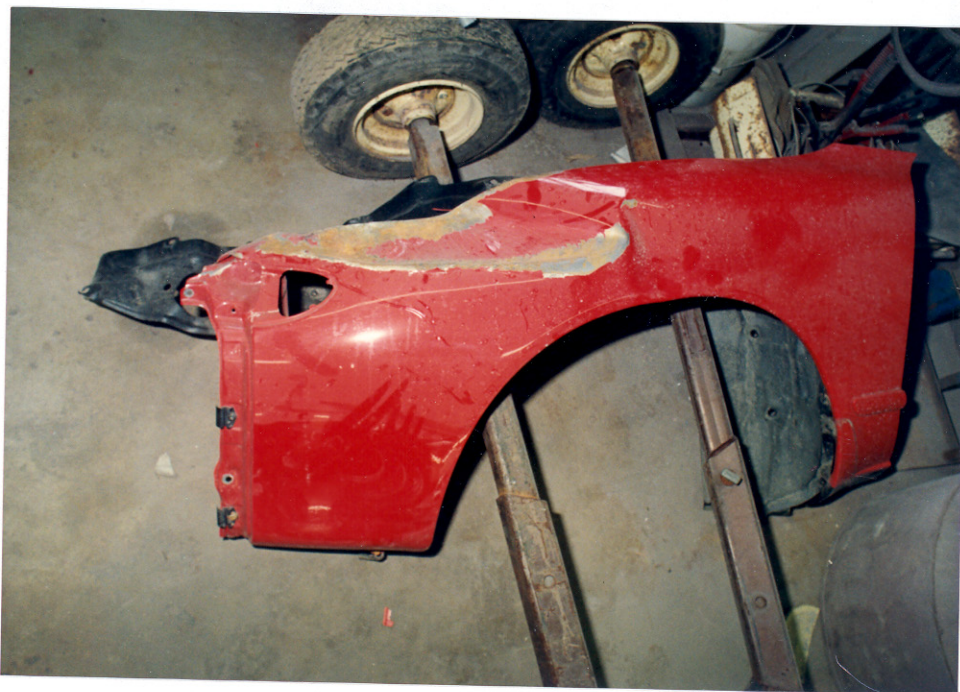
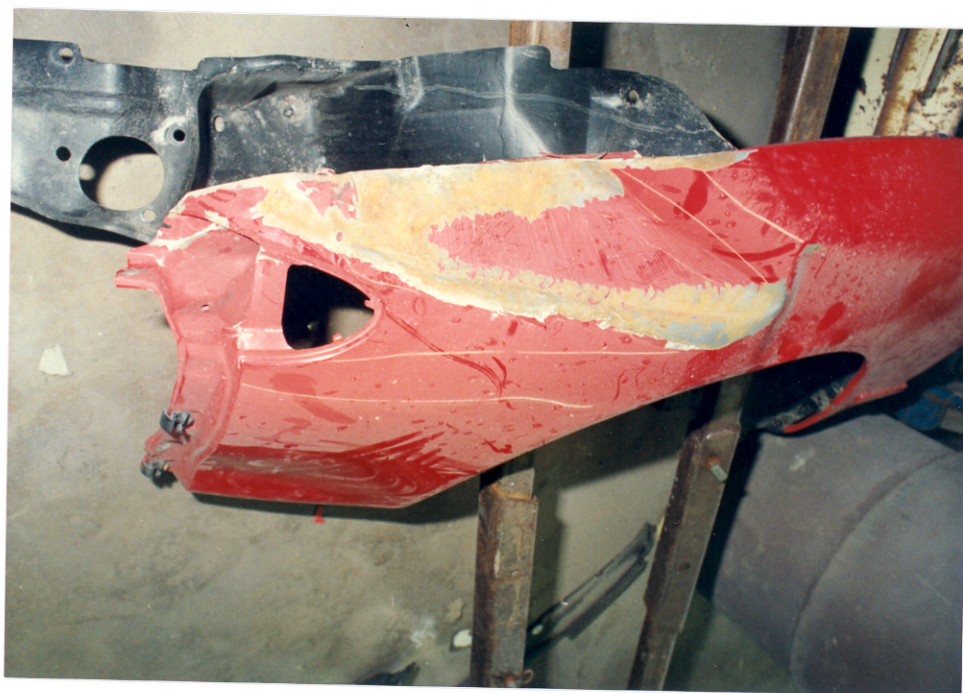
Damage to the top surface of the left front fender

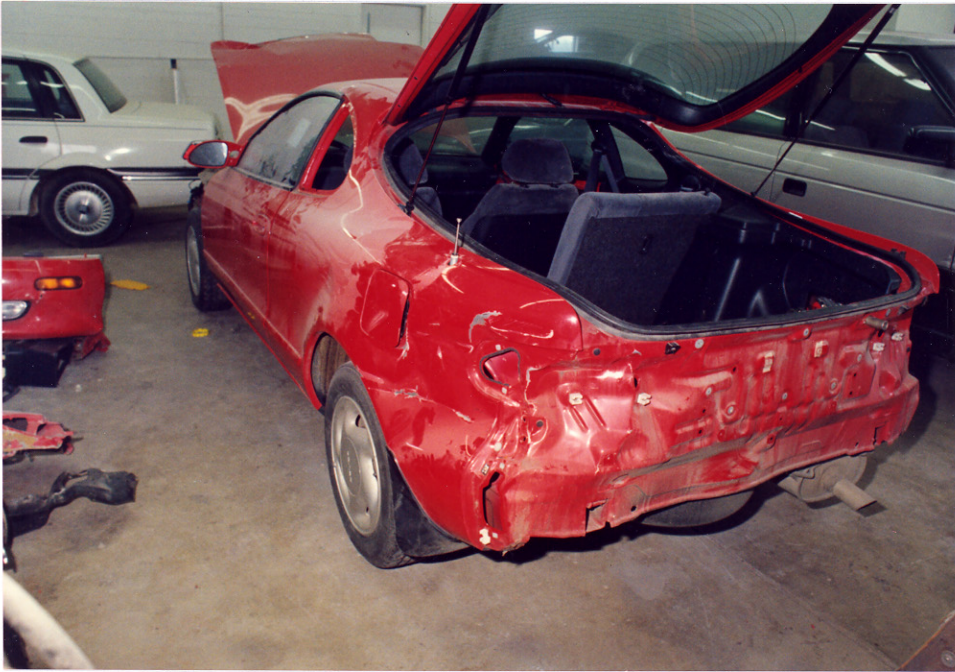
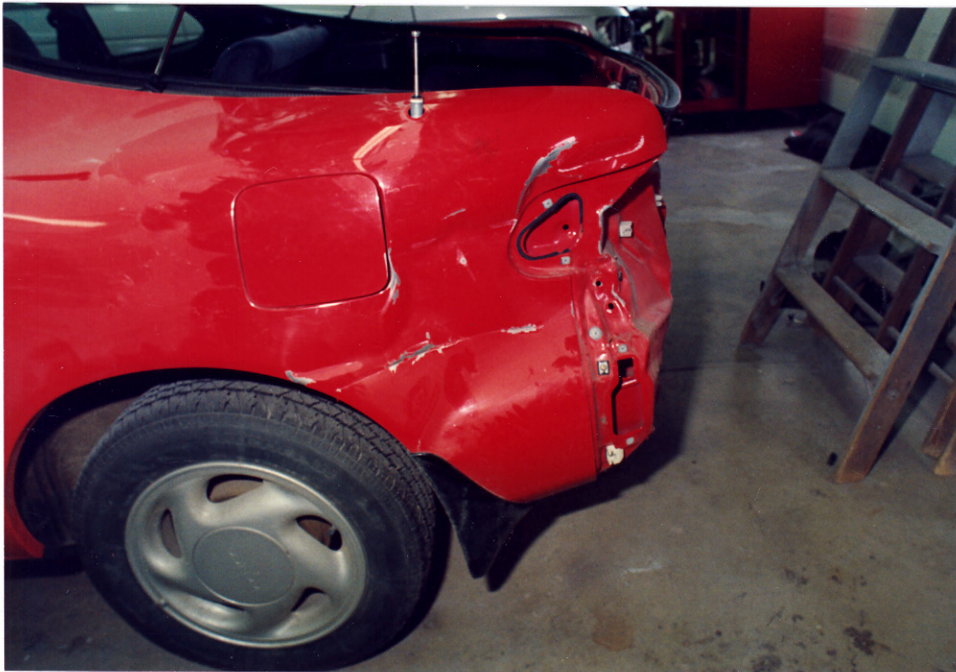
The left rear quarter panel area of the Toyota Celica impacted the box beam median barrier as the vehicle rotated approximately 15-25° in a clockwise (CW) direction. The 11 o'clock direction of force (CDC: 11-LBES-2) impact resulted in minor sheetmetal damage to the vehicle. Direct contact damage began 6.75" rearward of the left rear axle and extended 19.75" rearward. Maximum crush was approximately 2.0" located 12" rearward of the axle position. There was no residual or direct contact damage to the rear bumper facia or bumper reinforcement bar. The lower edge of the box beam medium barrier was 20" above a raised concrete curb. A snow and ice buildup obscured the face of the 6" barrier curb and transformed it into a mountable surface.

Damage to the left rear quarter panel from the median barrier impact sequence

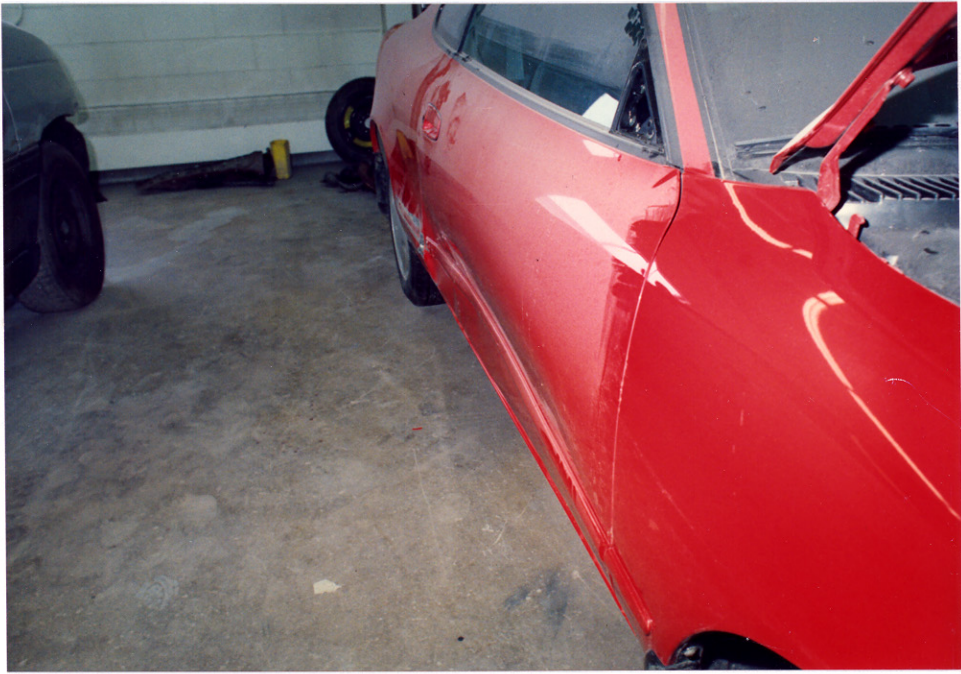
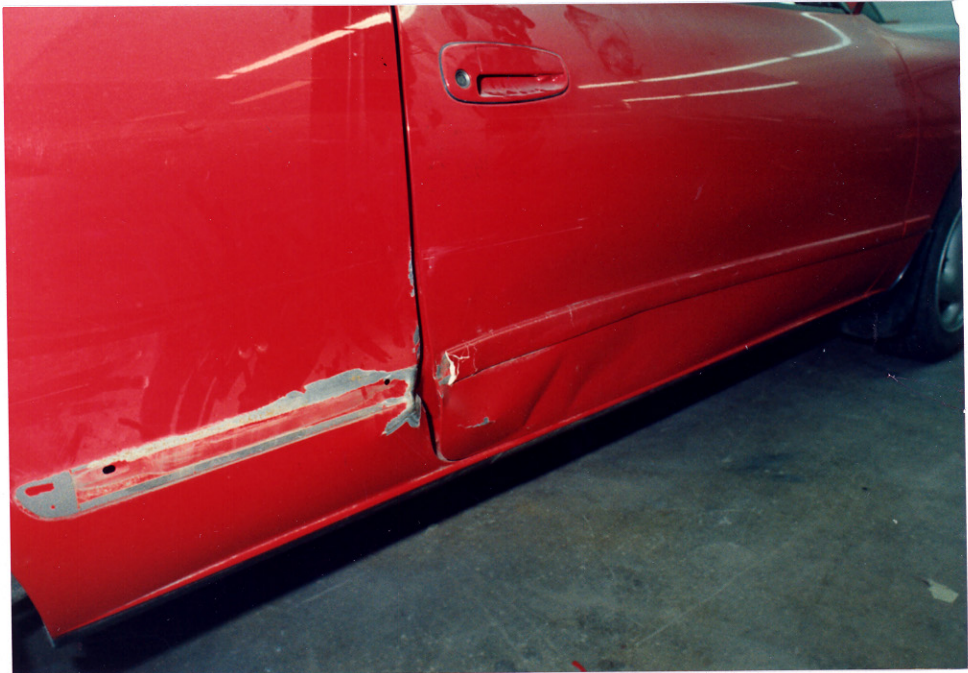
The left front bumper corner area of vehicle #2 sideswiped the right door and quarter panel area of the air bag equipped Toyota Celica. Direct contact damage on the Celica began 70.25" forward of the right rear axle and continued rearward to the rear wheel opening, ending 8" forward of the rear axle. Maximum crush was 1.5" located on the rear 1/3rd of the door, 45.5" forward of the axle position. Crush values at the rub strip level of the door and quarter panel were as follows: $C_1 = 0.0$, $C_2 = 0.0$, $C_3 = 0.5$ ", $C_4 = 1.25$ ", $C_5 = 0.375$ ", $C_6 = 0.0$ ". The Toyota sustained a 12 o'clock impact force (CDC: 12-RZES-1) from the minor severity sideswipe impact configuration. As a result of the impact sequence with vehicle #2, the Toyota yawed slightly in a

Sideswipe damage from contact with Vehicle #2

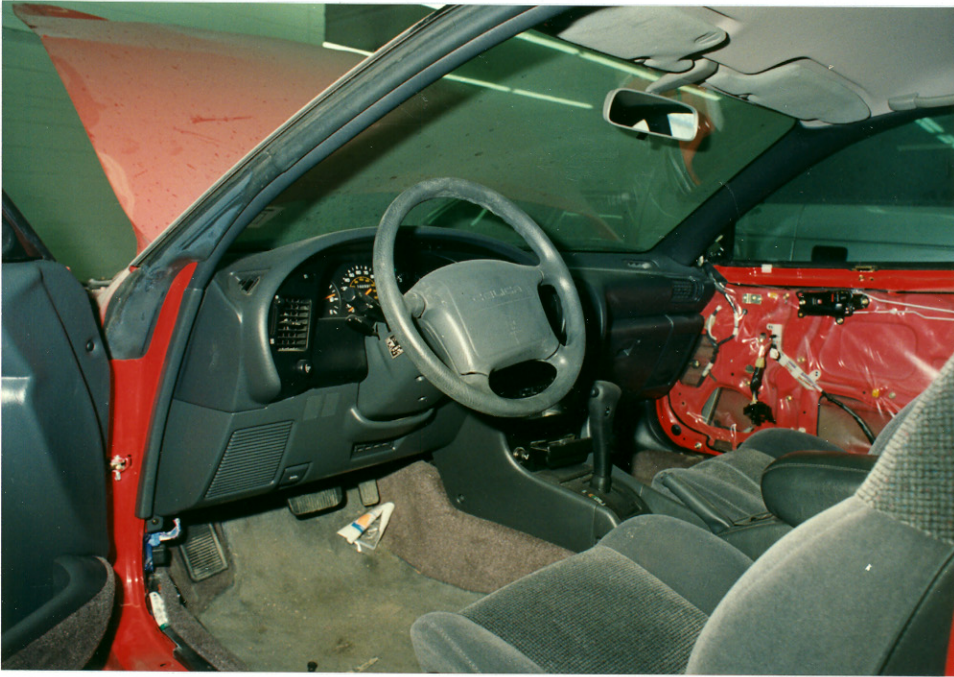
Following our inspection of the vehicle, reconstruction of the collision sequence, and diagnostic test of the air bag system, it is our opinion that the air bag system performed as designed and should not have deployed in this crash.

Nondeployed driver air bag module

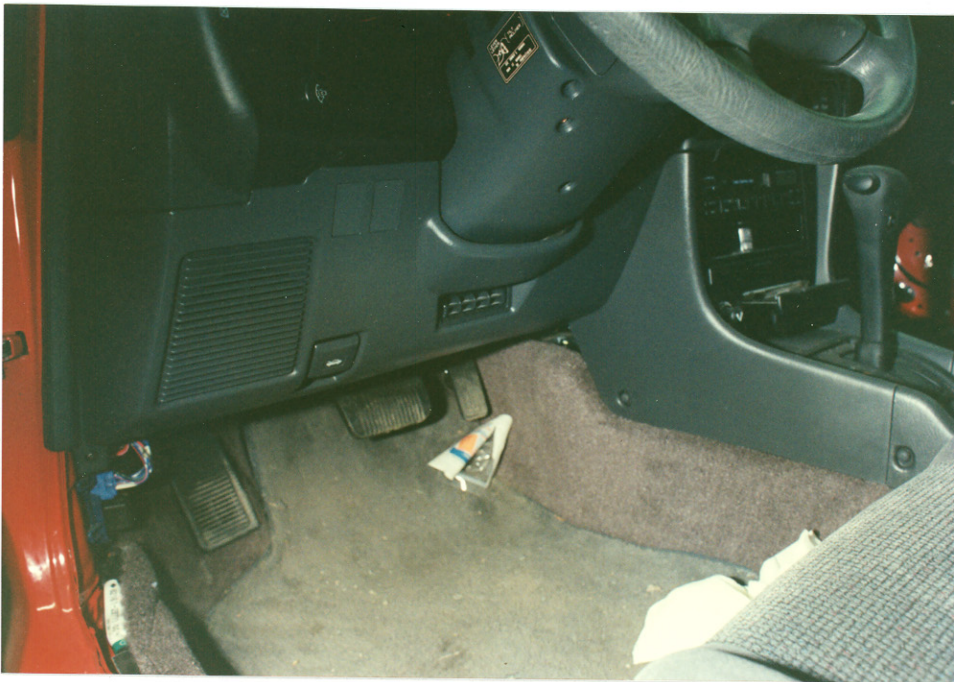
Knee bolster, no occupant contact

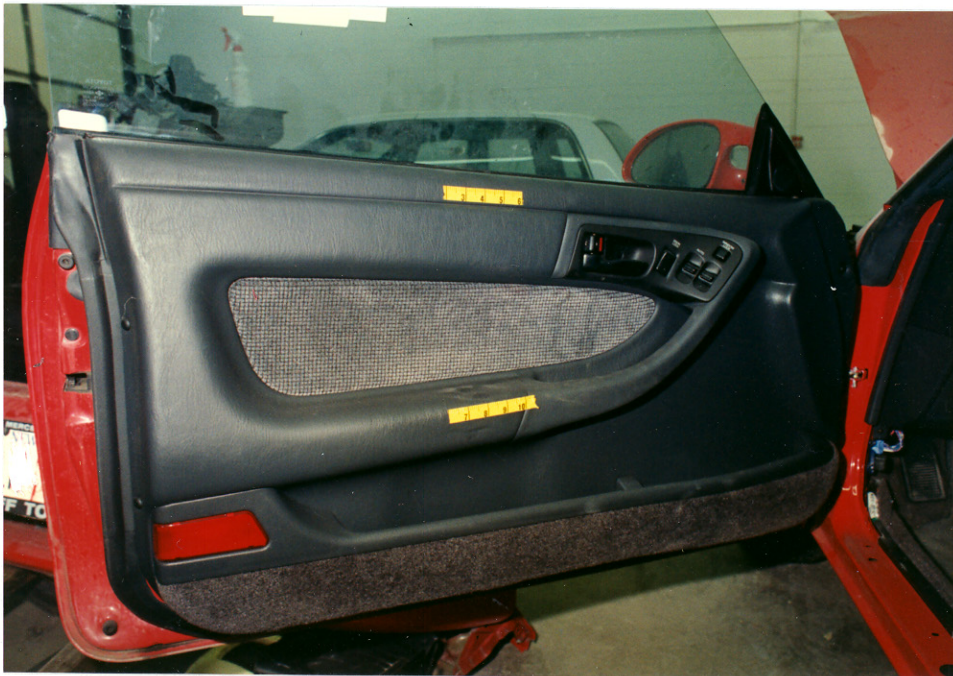
Probable driver contact to the left panel
